55 50 SN / AF 23-33  
Diagnosis & Valve body Information

## Adapting to the Aisin Warner 55 50SN valve body

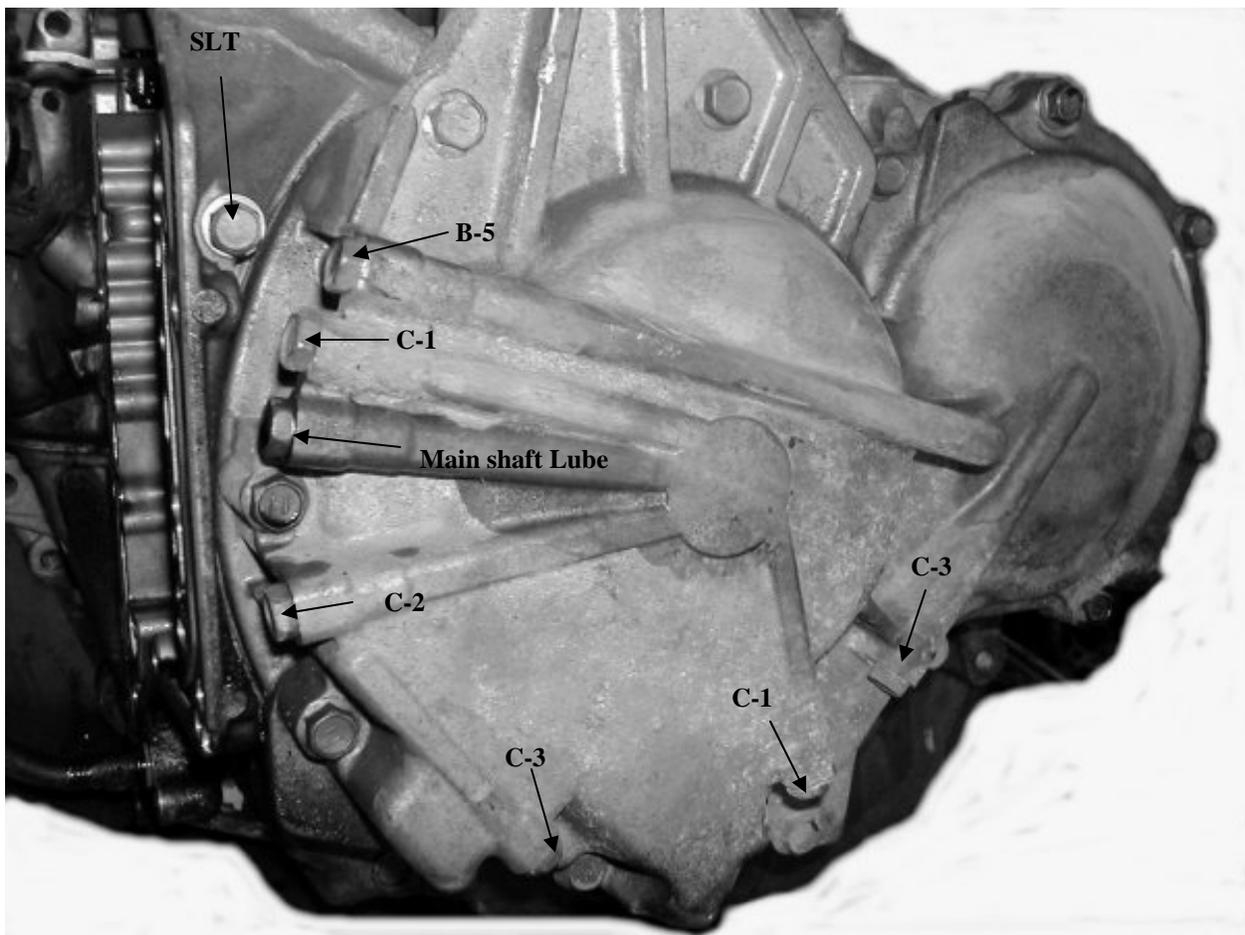
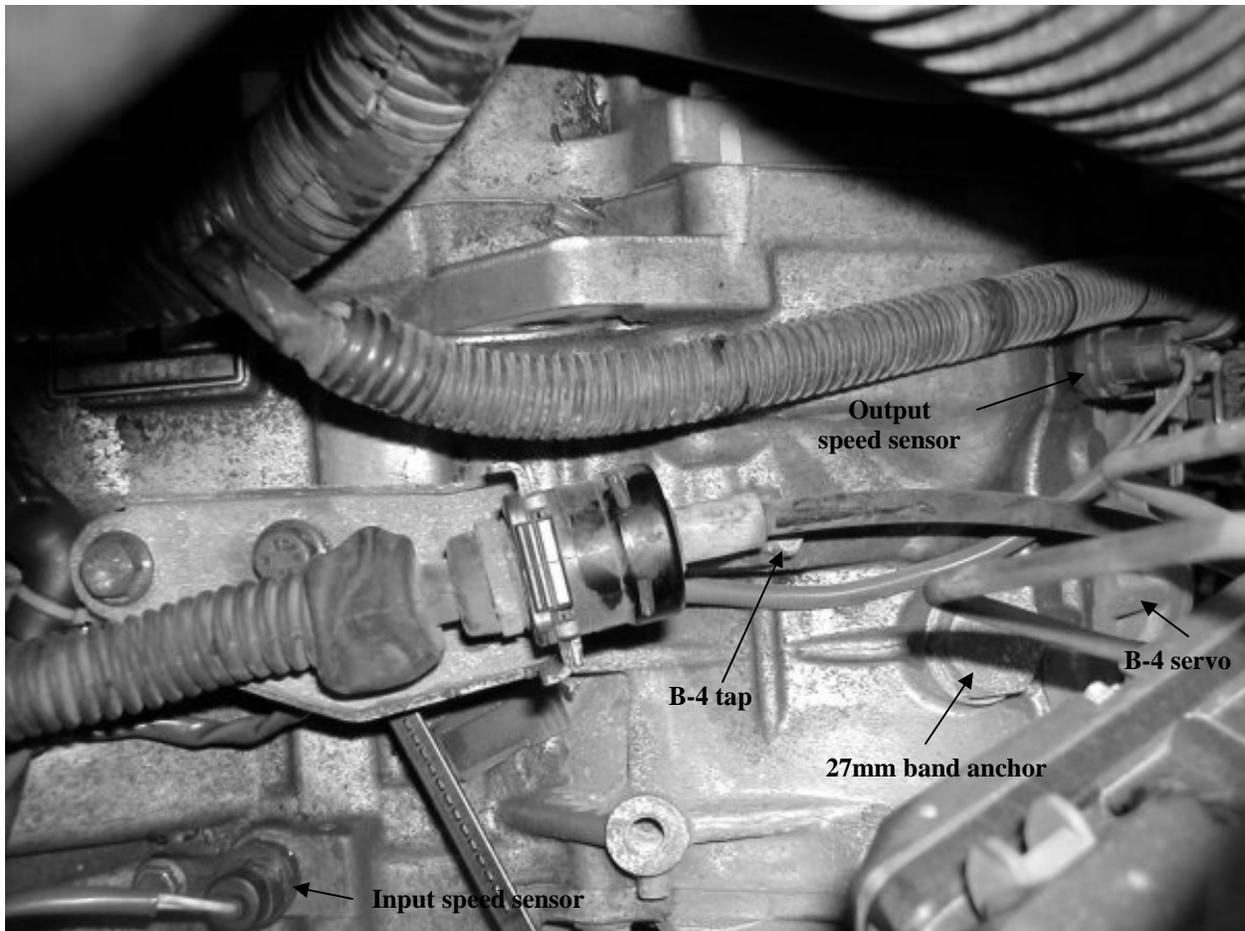
All the pressure plugs have a 12mm head. Do not mistake the 27mm band anchor (see Figures 1 and 2) for a fill plug or pressure tap. If that anchor is removed, the band will have to be recaptured. Positioning the band requires removal of the servo, at best and possibly the complete transmission.

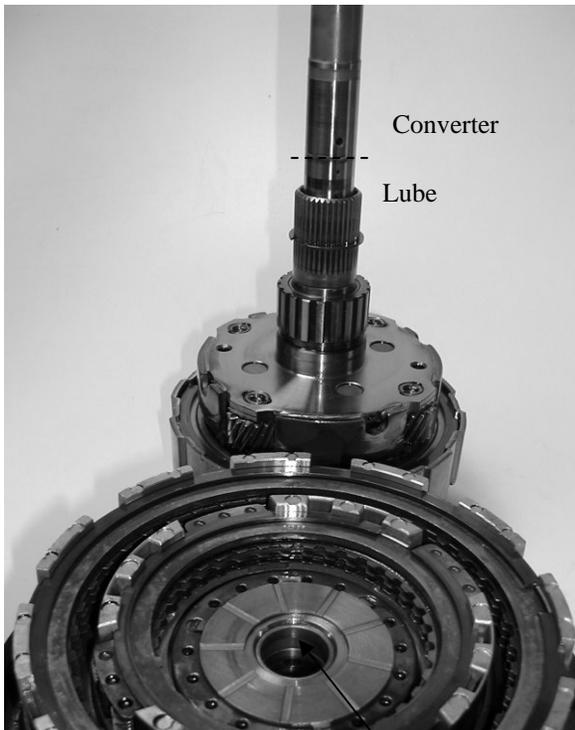
Critical pump stator bushing

Lube pressure and flow on the 55 50SN, is low in comparison to other units. This converter requires multiple valves, along with the rear pump bushing, to control modulated TCC apply (see Figure 3). The converter clutch may remain fully applied at very low speed and high load, which taxes the fluid and lining, creating a break-away slip or RPM fluctuation.

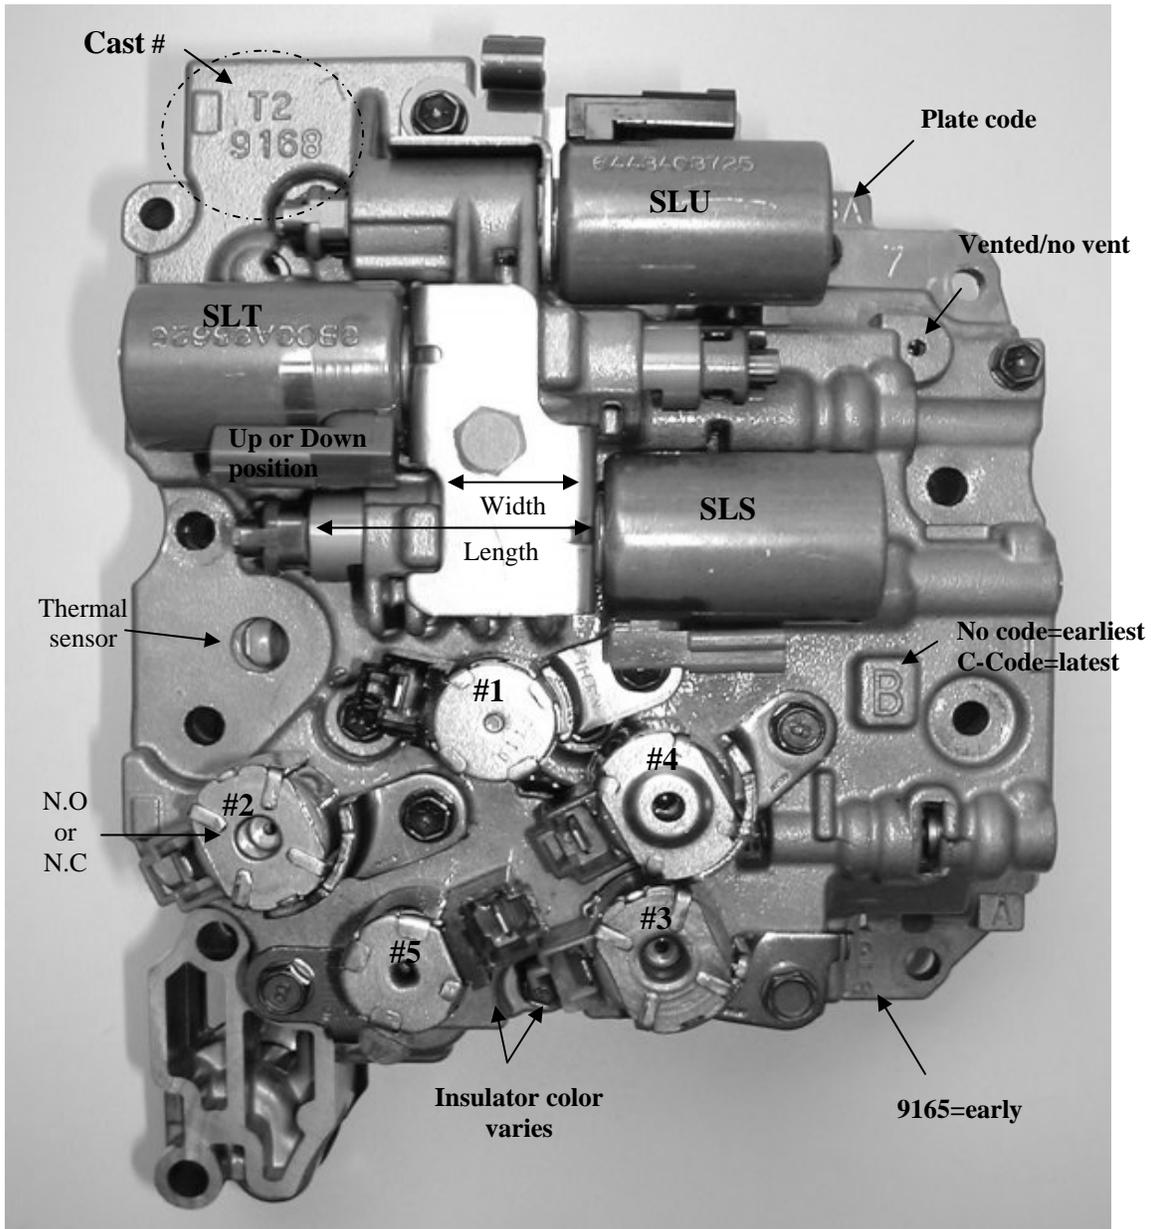
You can perform a similar air test (ill#4) with the valve body itself. When doing so, the pump line port and thermal element hole must be closed and the separator plate held as shown to eliminate cross leaks. This might sound confusing in print, but when you do it, the ports will be evident and easy to close with an opposite hand.

If you pressurize the SLT port with shop air ( 80-100 psi), air pressure will push fluid, which you see as a leak. Problematic leaks occur at the steel side cover, SLT accumulator, B-1 and C-1 control valves. A major leak or combinations, cause delayed engagement or flare up-shift and should be inspected after disassembled.

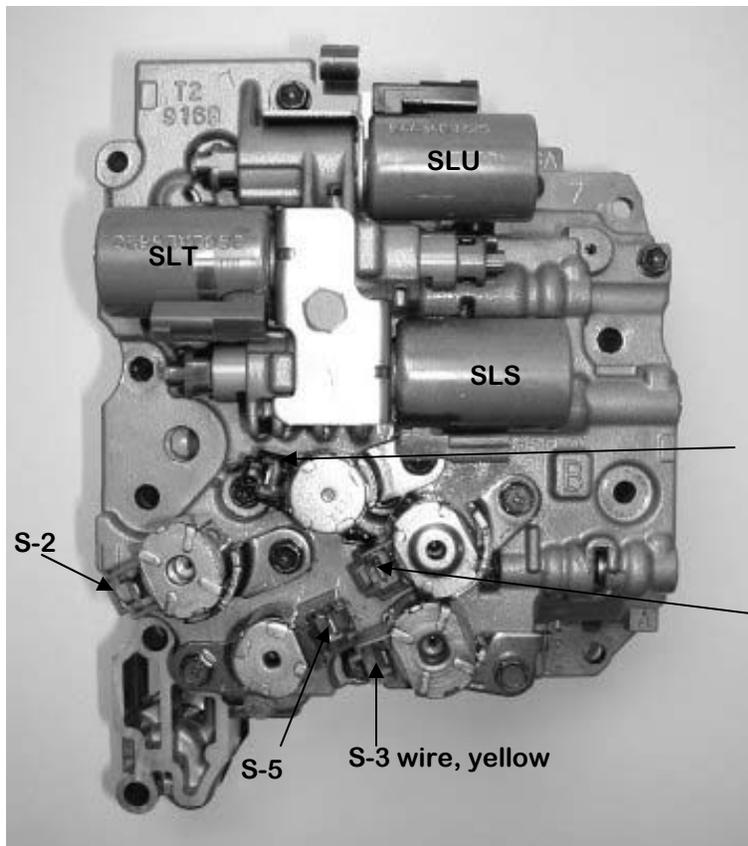
**Wiring Issues (see photo left)**

- Common to mix up connectors from harness
- S1- White wire, right side loom.
- S3- Yellow wire, left side loom.

S-1 wire, white

S-4

S-3 wire, yellow

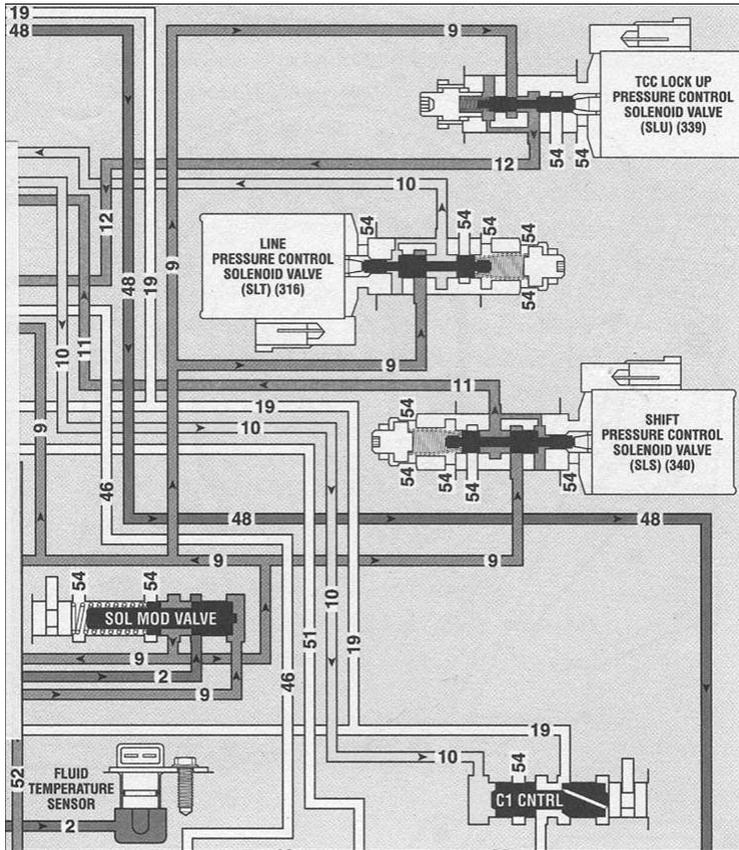
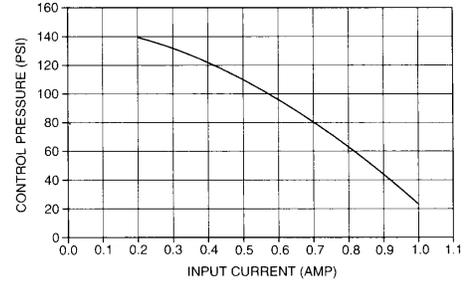
LINE PRESSURE CONTROL SOLENOID VALVE CURRENT FLOW

**Note:** This OE chart is referring to line pressure. Actual SL output is limited by solenoid modulator valve to 80 psi.

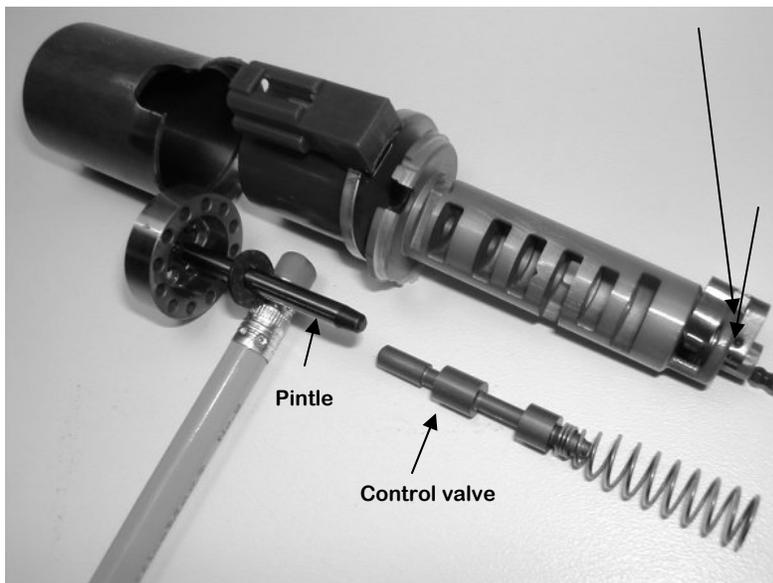
**Measurement:**  
End of solenoid manifold to shoulder on adjuster

**SLT-SLS**  
Preliminary adjustments: .010"-.050", record prior to removal.  
Measurement taken with retainer removed. Shoulder of adjuster to end of manifold.  
Turning screw inward, raises SLT & SLS pressure  
6 clicks = 1/2 turn.  
Turning screw inward, reduces SLU  
6 clicks = 1/2 turn.

- Adjustment clicks are created by the increments on exterior of threaded allen, 3mm
- With control valve removed, shaking the coil should result in a free pintle movement.

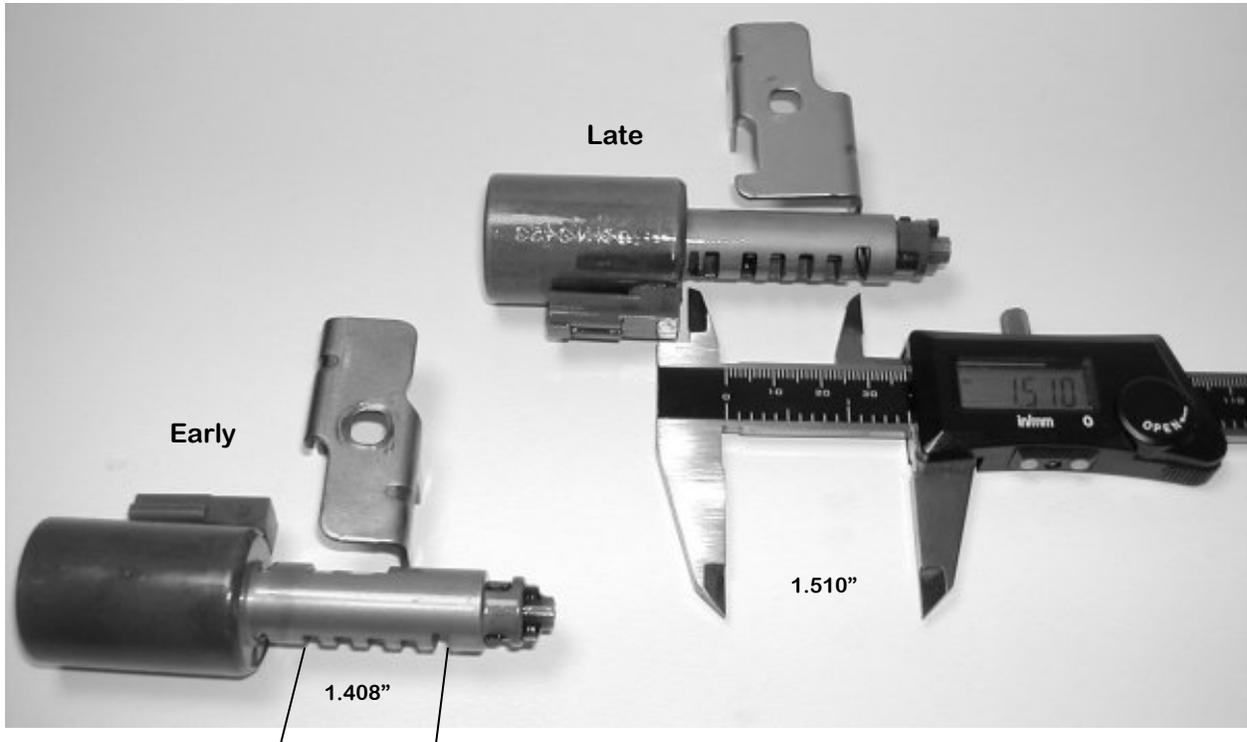
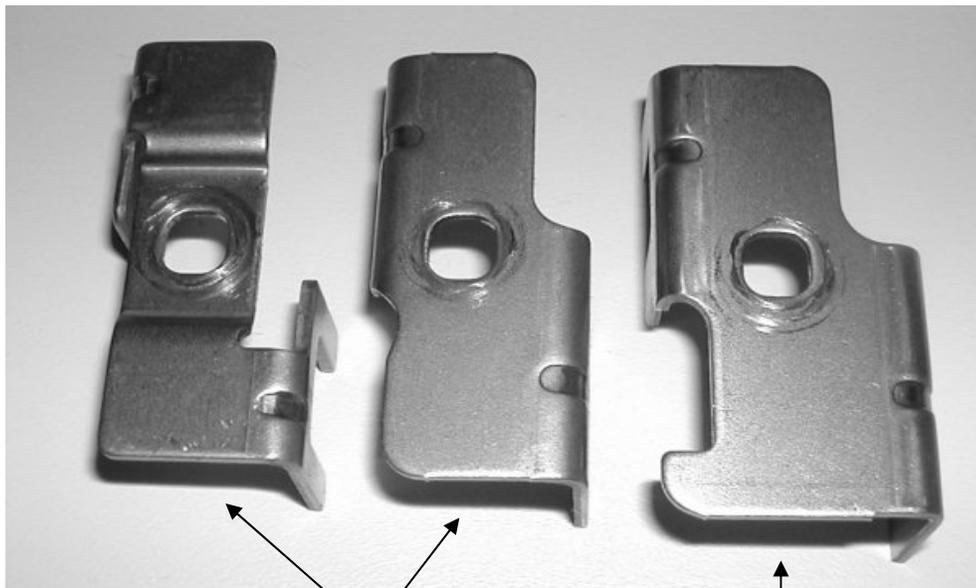
Early short brackets

Long late bracket

SLU-Remains same Early-Late

SLT-Early

- Slot for bracket results in solenoid connectors upward.
- Bracket is narrow type
- Distance bracket slot out ex. 1.408" (short manifold)

SLT-Late

- Slot for bracket results in connector down
- Wider bracket
- Long manifold 1.510"
- Connector down requires special harness, Volvo update.

SLS-Early

- Slot for bracket requires connector up.
- Narrow bracket
- Short manifold 1.408"

SLS-Late

- Slot for bracket requires connector up.
- Wide bracket
- Long manifold 1.510"

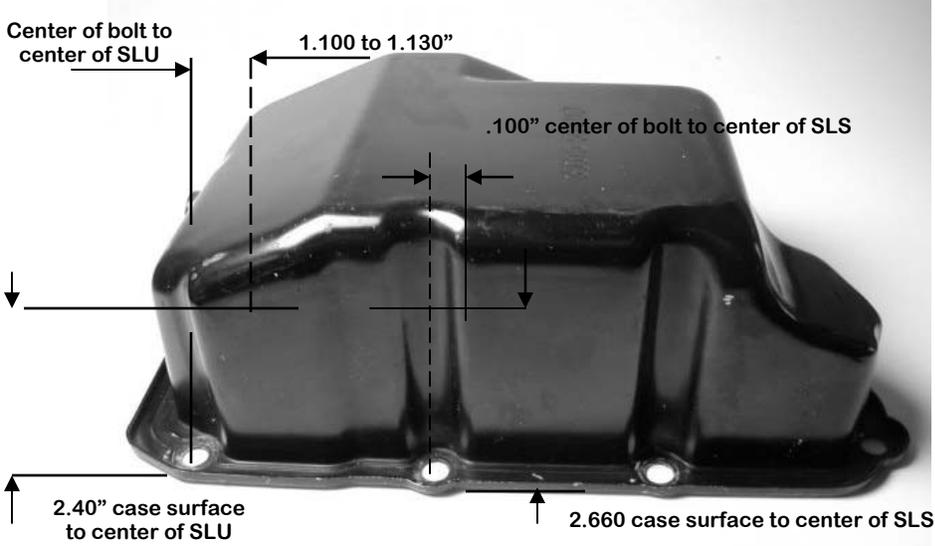
The side cover can be drilled and plugged to adjust the linear solenoids. Cover must be removed for this procedure!

Hole size depends on what plug you use. 1/4" blind head rivets are an option. Seal with silicone upon install.

- The solenoid can be adjusted if a pass-through hole has been located in the cover during bench rebuild. ( figure ). The SLU access will be at the top, left corner. A 3 mm Allen wrench, will pass approximately 1.60" or 40.9 mm. through the cover, when it's inserted into the adjuster. You should be able to feel the Allen engagement. As you turn the Allen wrench you will feel the retainer click over the index. Always count your rotations, in clockwise (CW) or counterclockwise (CCW), so you know where you start /stop.  
CW/ In : Reduces SLU output.  
Resulting in: hard 1-2, 2-1 shifts and firmer/late TCC  
CCW/ Out: Increases SLU output. Resulting in softer shifts and earlier TCC

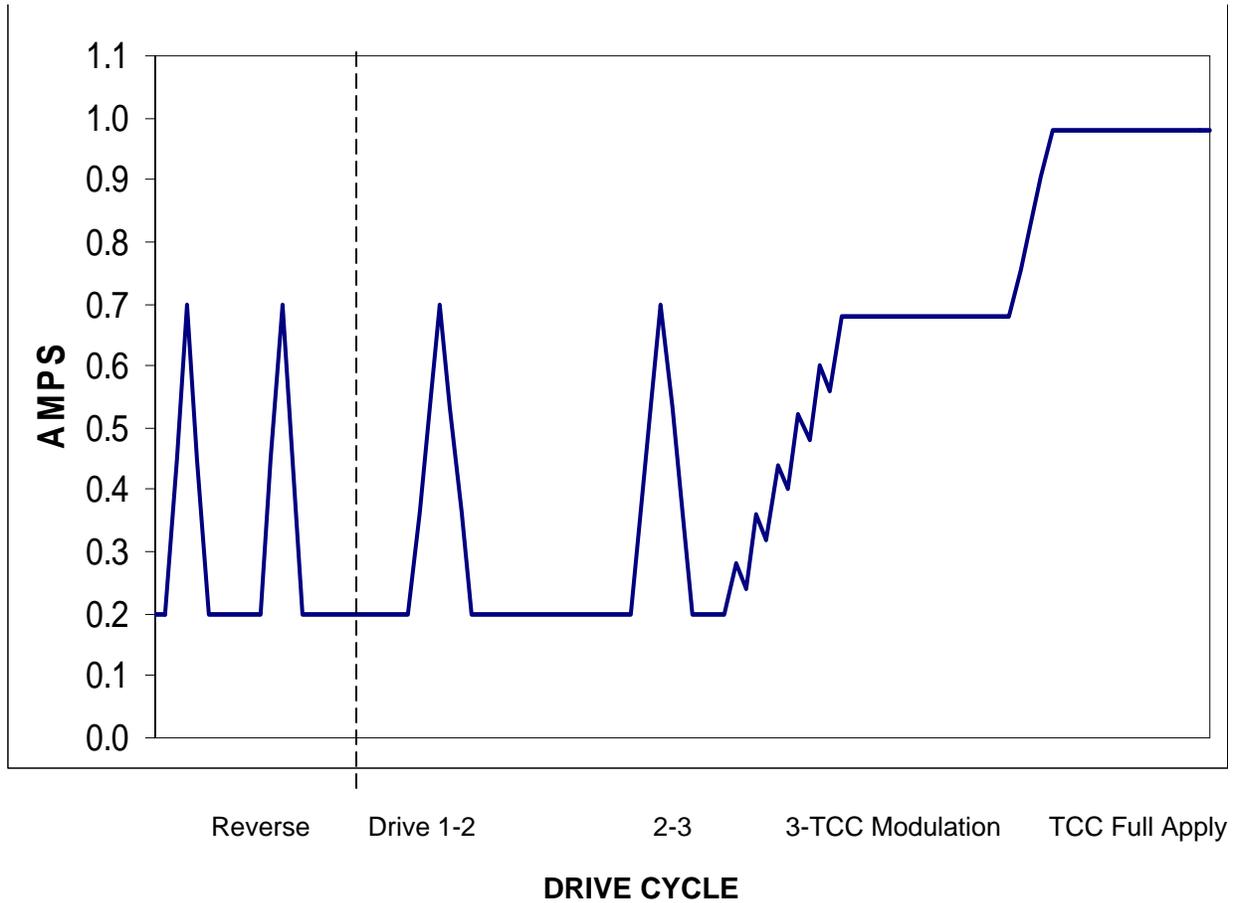
## SLU SOLENOID

High current causes high pressure

Solenoid is Normally closed (N.C.)

300 Hz operating frequency 15%-48% duty 1 AMP, TCC is off.

SLU controls 2nd clutch (B-2) and low reverse (B-3). Manual low for engine, braking

SLU- Has been know to create 1-2 slip, 2-1 harsh downshift if not adjusted or defective. It also can over heat fluid and affect TCC apply.

SLU generally controls TCC right after 2-3, and will maintain TCC apply coasting or cruise at 25 mph.

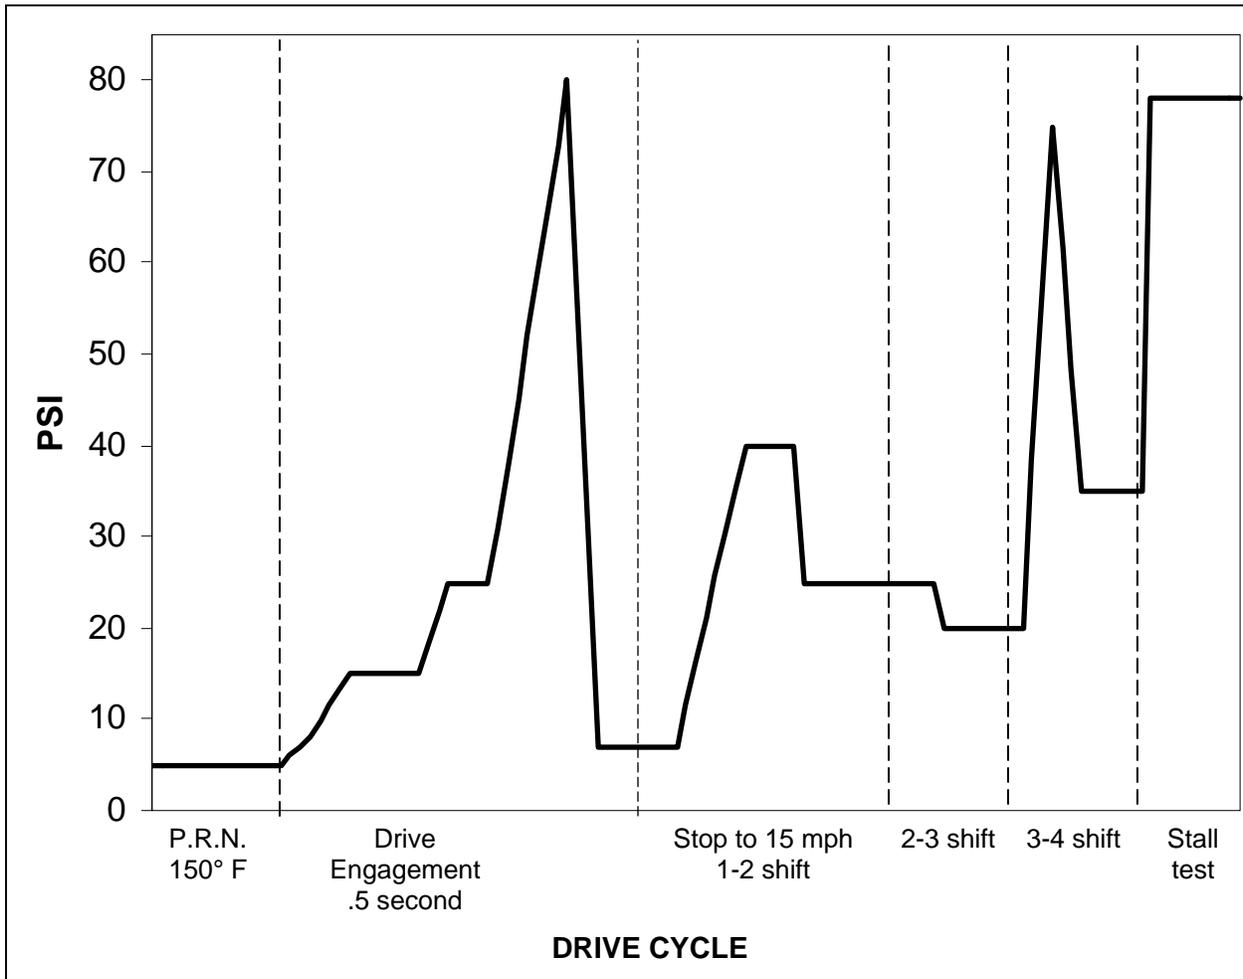
## SLT SOLENOID

300 Hz operating frequency 15%-48% duty  
 SLT is normally open solenoid (N.O.)  
 Low current causes higher pressure (inverse proportional)

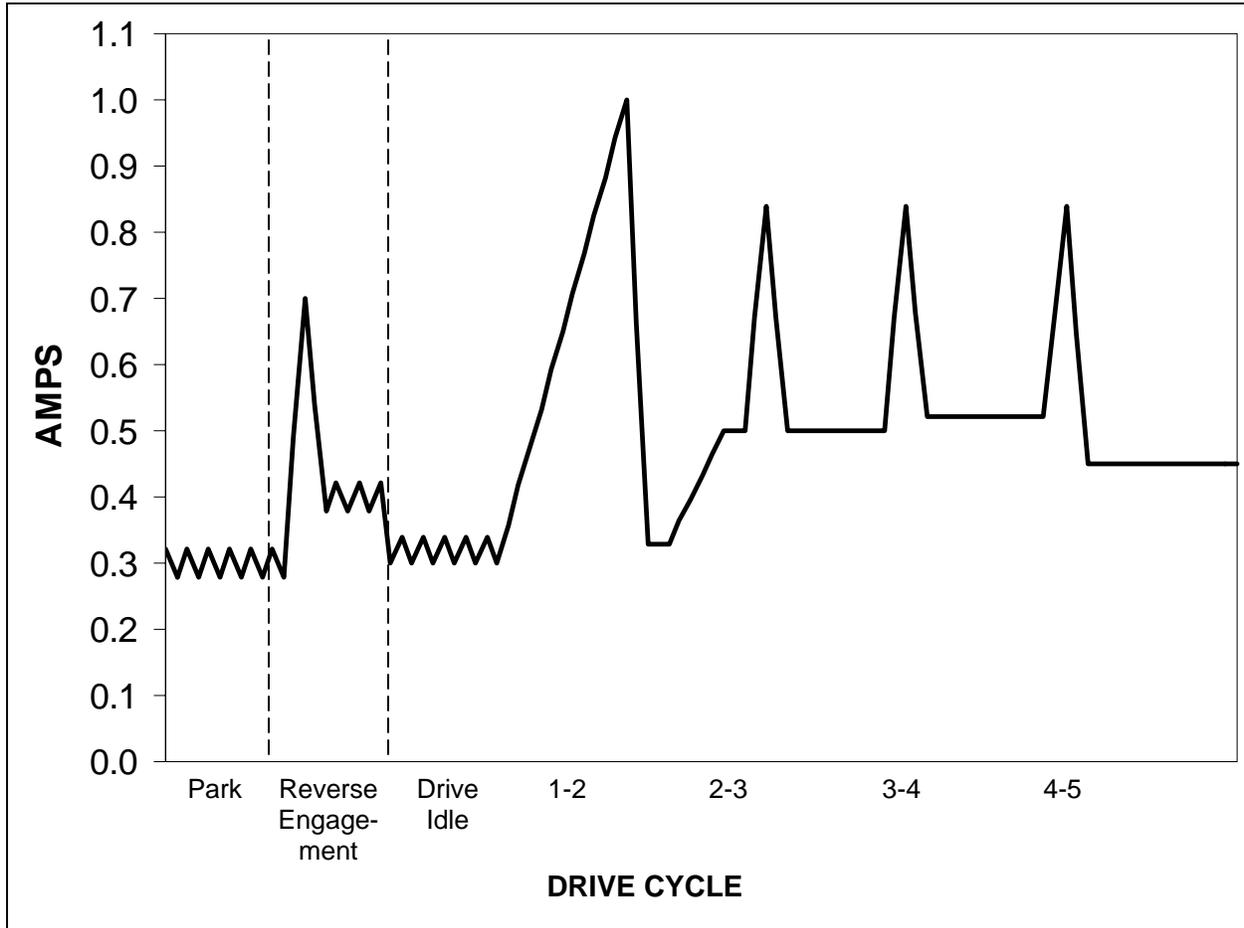
## SLS SOLENOID

300 Hz operating frequency @ 15-40% duty

SLS is normally open solenoid (N.O.)

Low current causes higher pressure (inverse proportional)

This solenoid is spiked to increase clutch feed, then modulated between shifts.

Coast down shifts are modulated also with a pressure rise after each shift.

SLS controls: 2nd, 3rd, 4th, B-1 brake, 5th, Reverse, C-2 clutch

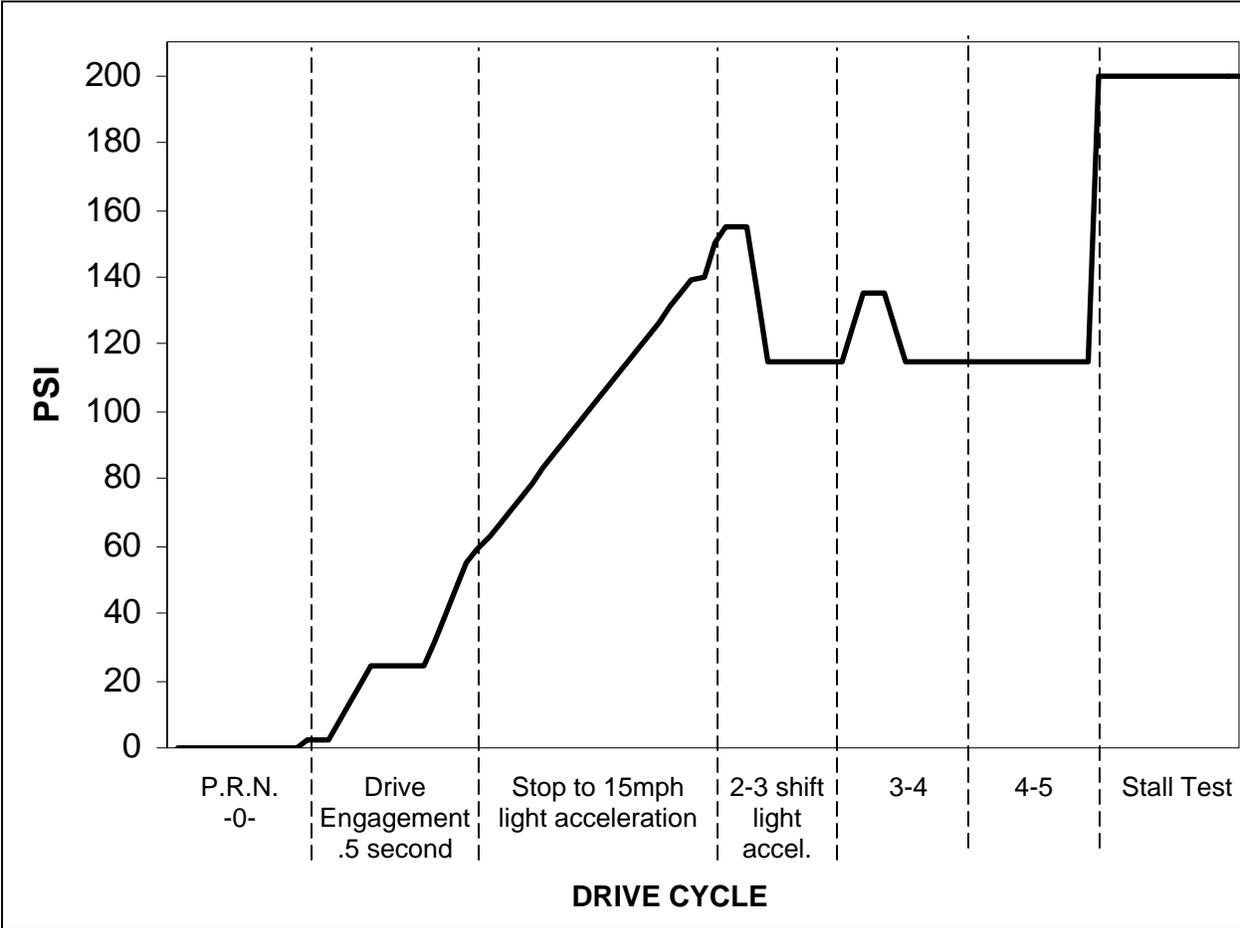
### C-1 CLUTCH PRESSURE

Note: If C-1 pressure upon initial engagement is 160 instead of the 50-60 psi, the TCM has commanded a pressure rise. Verify with SLT amperage, then check for codes and electrical issues.

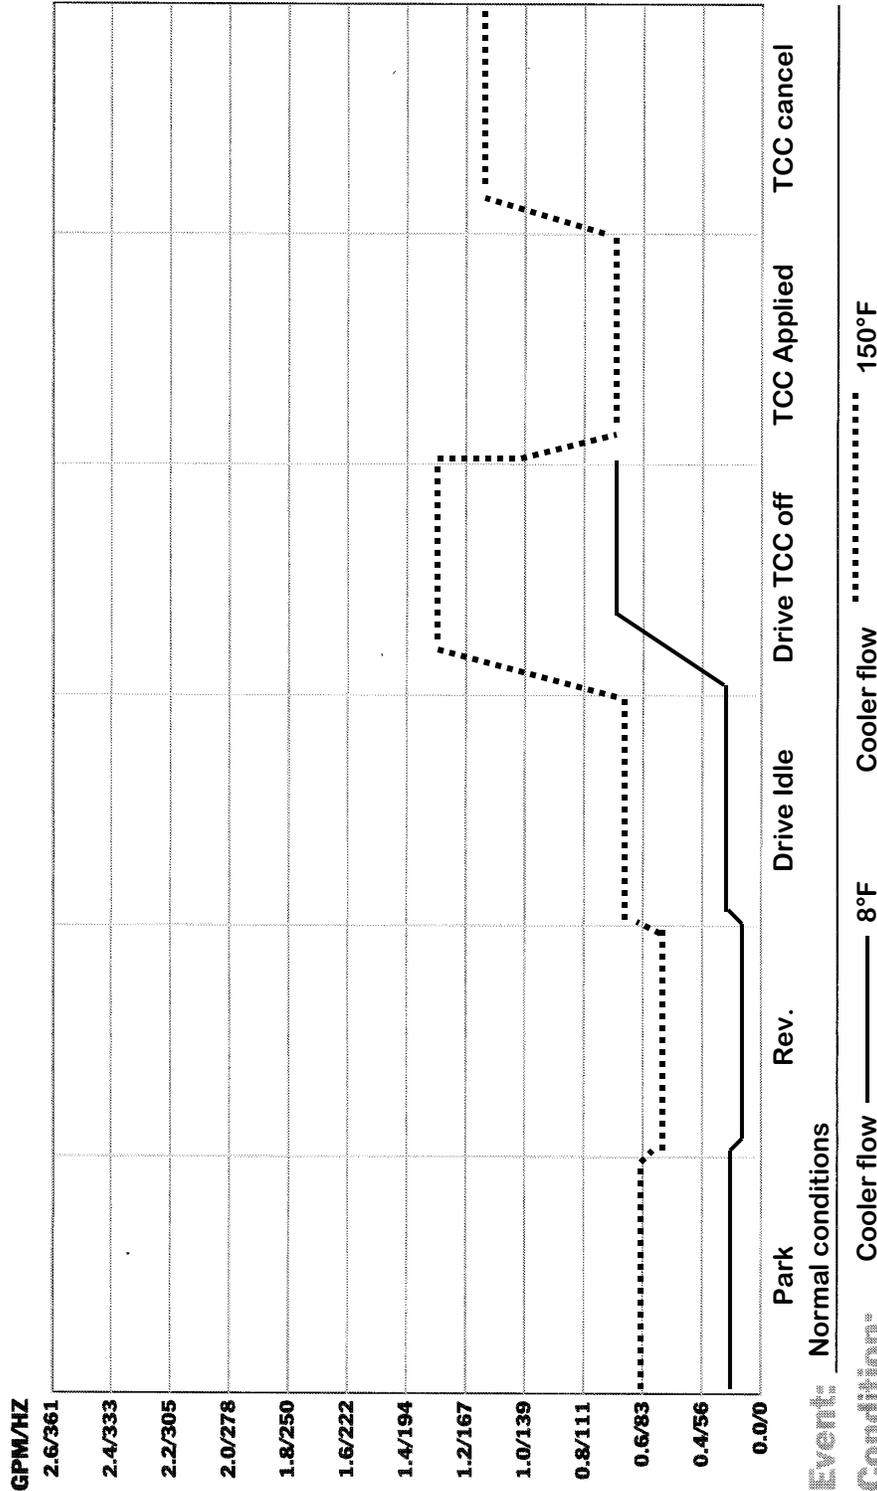
APPLICATION: 55 50 SN &/or AF23/33 Volvo '02 (130,000 m)

Event: Normal conditions

Condition: Cooler flow — 8°F Cooler flow ..... 150°F

Lube pressure: 8° F 12 psi P 150° F 9.0 psi P  
 OEM: 8° F 34 psi Revs. 150° F 9.2 psi Revs.  
 Cooler lines: 8° F 24 psi Drive 150° F 6.0 psi Drive

Volvo: Return to the transmission comes into top of side cover. AF 23/33 cooler return line is furthest from bell housing.

G.M. states: Minimum of .75 gpm at 60 psi and 2.6 gpm at 140 psi and 200° F. It is equally important to tap the lube circuit on this unit. Lube is on end cover at 9:00 position.

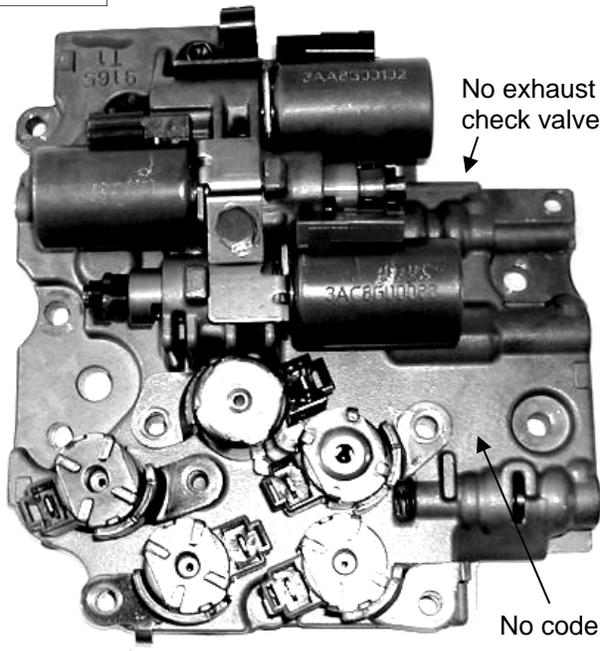
Fig. 1

This casting does not match the GM AF-23 oil circuits in Blue Technicians guide.

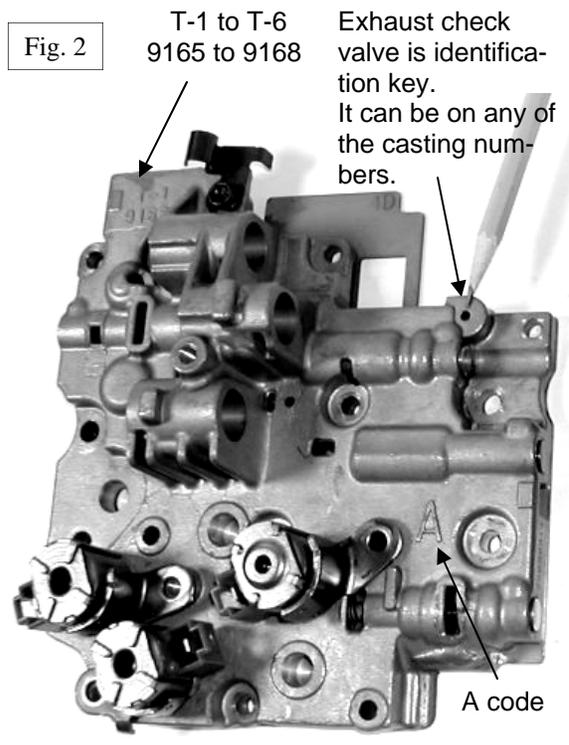
Fig. 2

Code: No = Early  
C is late

Typical of the updated Volvo, C valve body

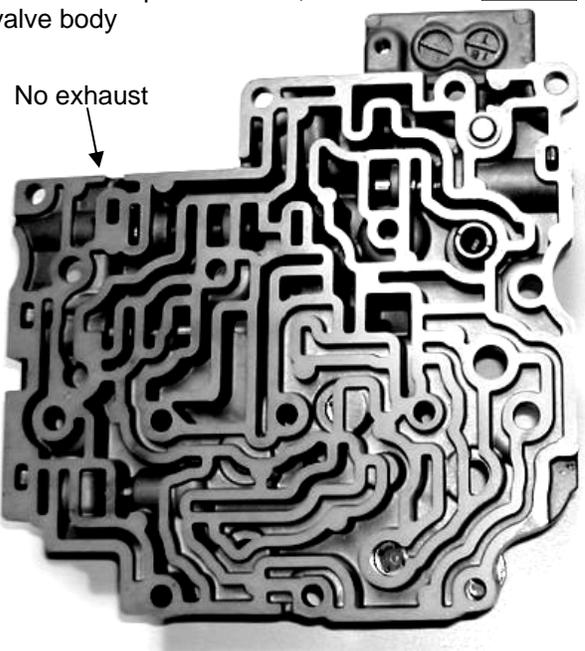
Fig. 1

Exhaust Casting matches GM AF-23 Technicians guide oil circuits.

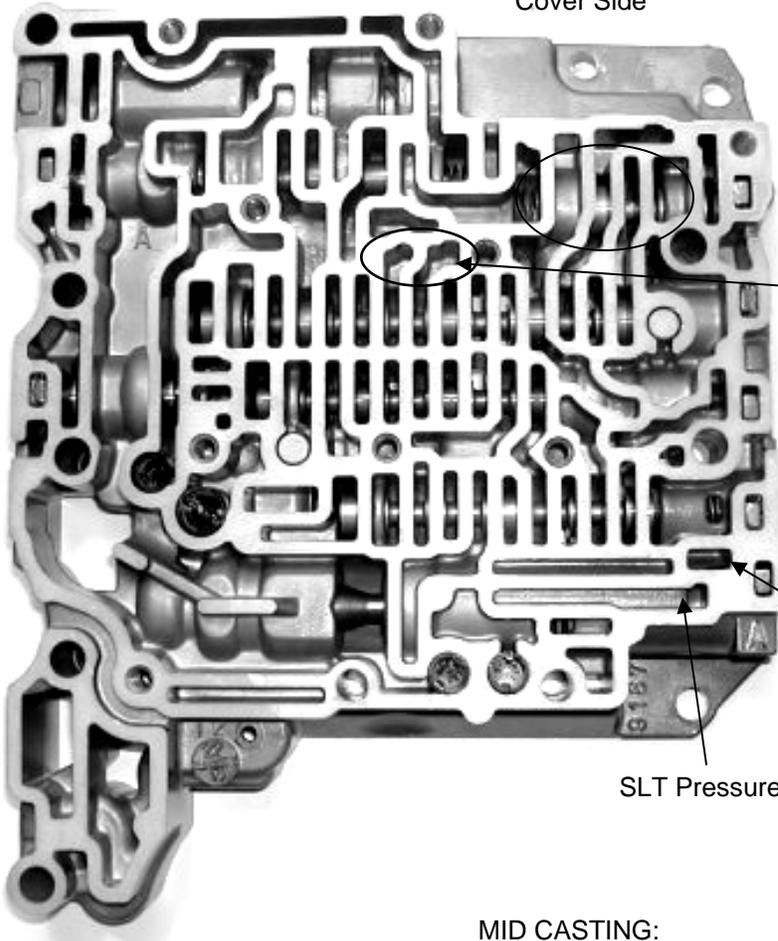
MID-CASTING:  
Cover Side

- Inspect for visible wear & scoring.
- Vacuum Test, minimum of 18" vacuum.

This casting (two flags):  
Must go with exhaust type  
plate and front control.

\*One flag on right only:  
Assembles with a non-exhaust  
plate & front control.

Boost sleeve vacuum test

SLT Pressure

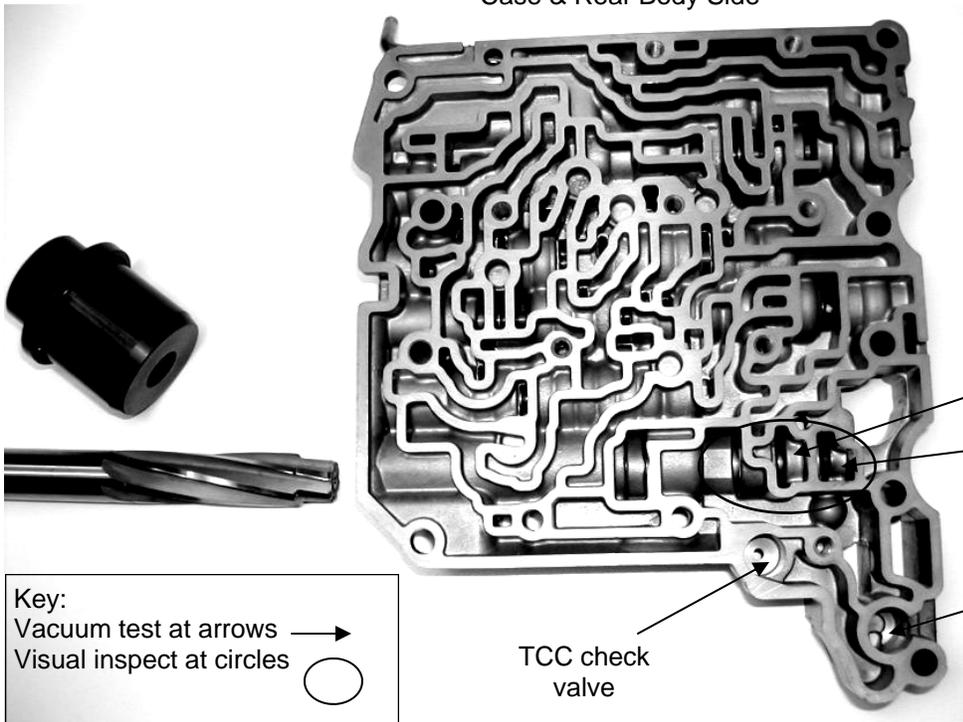
MID CASTING:  
Case & Rear Body Side

Vacuum test for  
pressure  
regulator valve  
bore wear.

Cooler bypass.

TCC check  
valve

Key:  
Vacuum test at arrows →  
Visual inspect at circles ○

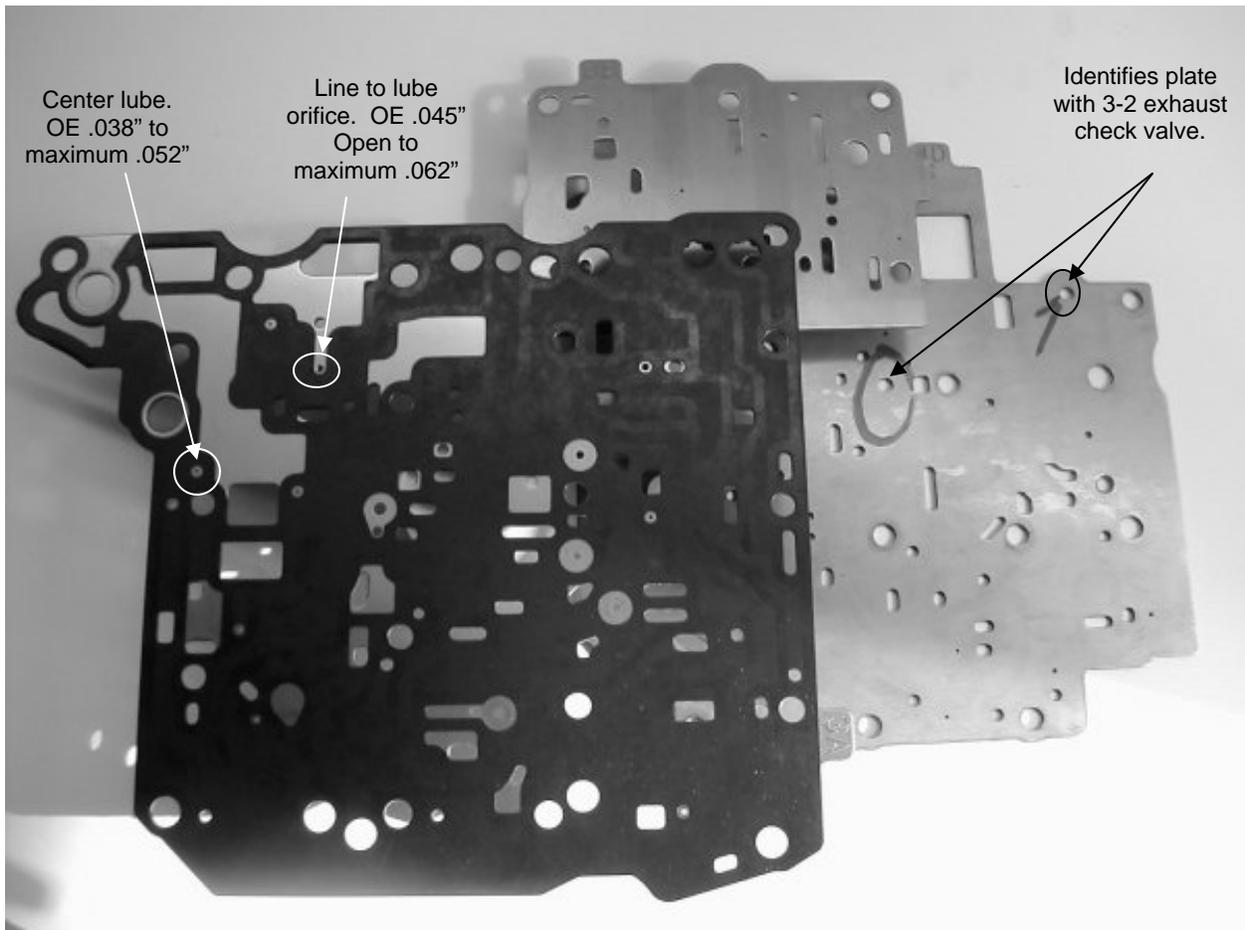
Identification:

Plates must match the top & middle casting

A separator plate modification can be performed, if the secondary regulator bore has minimal wear. This modification will increase lube and converter feed oil flow. Enlarging the plate feed holes is not suggested if the valve body casting has excessive wear at the secondary regulator bore, in the area of the spring to spool surface.

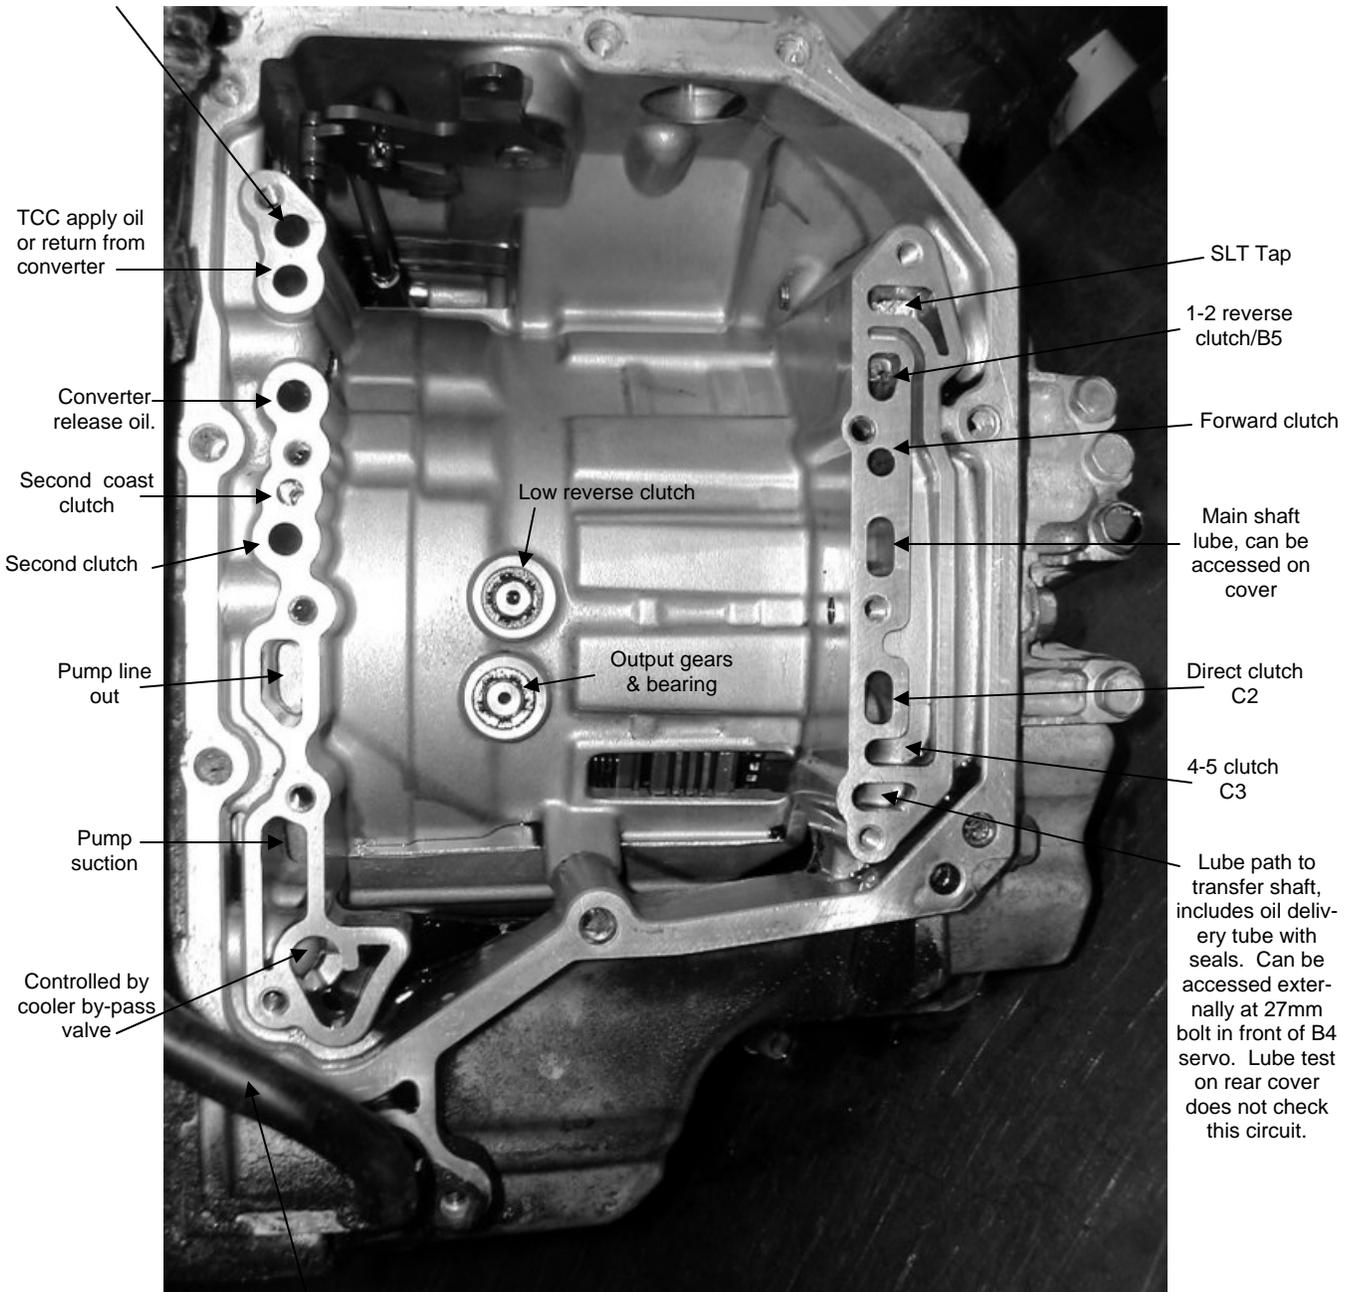
Volvo pictured  
 Converter out line to cooler. Cooler returns into valve body cover.

AF 23/33  
 Left side is converter out, right is return to sump.
